Intel[®] Pentium[®] III Xeon[™] Processor Specification Update

Release Date: May 2005

Order Number: 244460-041

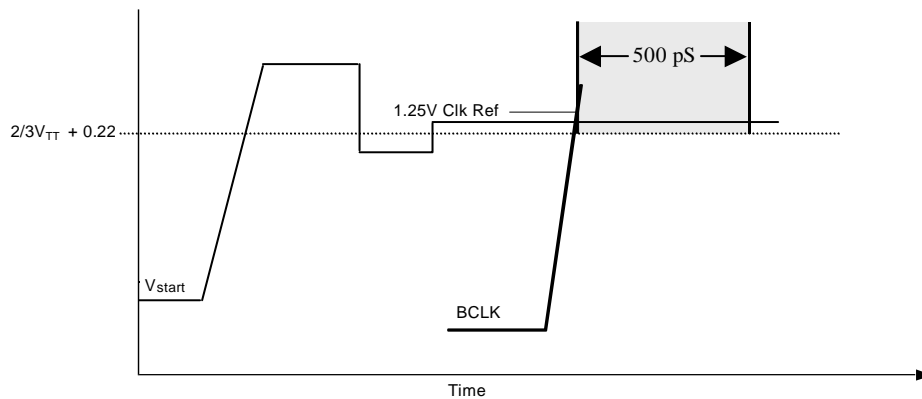
The published AGTL+ AC specification for $V_{IH(MIN)}$ is $(2/3 \cdot V_{TT}) + 0.1$ Volts.

Intel has characterized the new AGTL+ AC specification for $V_{IH(MIN)}$ on the processor's RS0# signal to be: $(2/3 \cdot V_{TT}) + 0.22$ Volts within 500 picoseconds following the rising edge of BCLK crossing the 1.25V Clk Ref. See below.

Implication: The deviation from the published specification results in decreased noise margin on the RS0# processor input. This decreased noise margin has been observed to be particularly detrimental in system environments where the RS0# processor input is being driven by an I/O buffer with a pull-up device (such as a p-channel transistor) that is switched off mid-cycle. Systems that employ I/O buffers that keep the pull-up device on for the entire cycle are significantly less affected by this erratum. The reduction in noise margin may lead to the generation of BINIT# (when enabled) resulting in a system reset, otherwise this condition may lead to a system "hang" condition.

Workaround: If a system design cannot meet the specification deviation, the following areas should be carefully examined to assure that additional margin exists in order to compensate for any deficit observed with respect to the newly characterized $V_{IH(MIN)}$ specification:

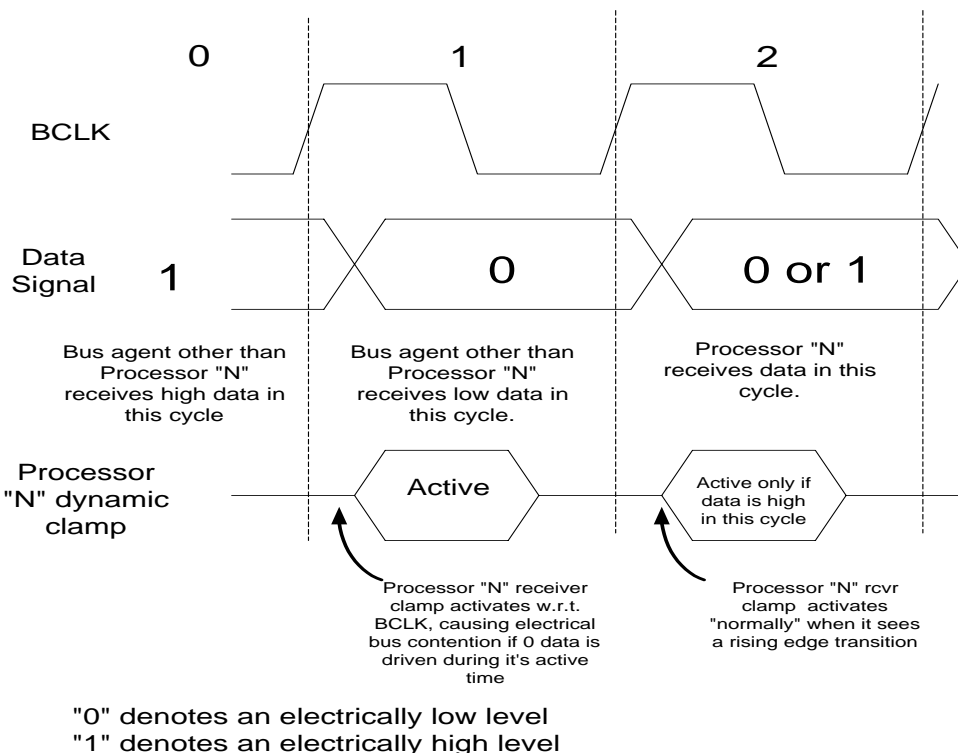
Problem: Falling edge ledge push-out and undershoot may be seen on AGTL+ data and data bus ECC signals. The AGTL+ receiver's dynamic clamp circuit activates (i.e. clamps the signal to an electrically high level) in certain cycles when data is driven to an electrically low level by another agent.

Implication: This erratum only occurs on a processor that does not receive data in that particular cycle. More specifically, this erratum only occurs when a specific processor does not receive data in the current BCLK period, but receives data in the very next period. Therefore, the processor inducing this falling edge noise (on data and data bus ECC signals) will not actually read the data in that cycle. See below for an illustration of this erratum affecting a processor denoted Processor "N". The falling edge ledges and undershoots may affect the signal quality and/or timing at agents that receive data in that cycle. Therefore, the impact of this erratum is highly dependent on system bus design.

Workaround: Evaluate system bus signal quality and timing margin at the valid receiving agent as a result of this falling edge noise. Due to dependence upon system bus design, bus layout may be evaluated to determine the need for improvements in signal quality and timing margin at the valid receiving agent as a result of this receiver-induced falling edge noise.
